# EXPANDED FUNGAL ASSESSMENT REPORT™

**Report Date:** 1/21/2026  
**Project:** 12345 Sample Rd.  
**LA Testing Order:** 322600000

**Proj:** 12345 Sample Rd.

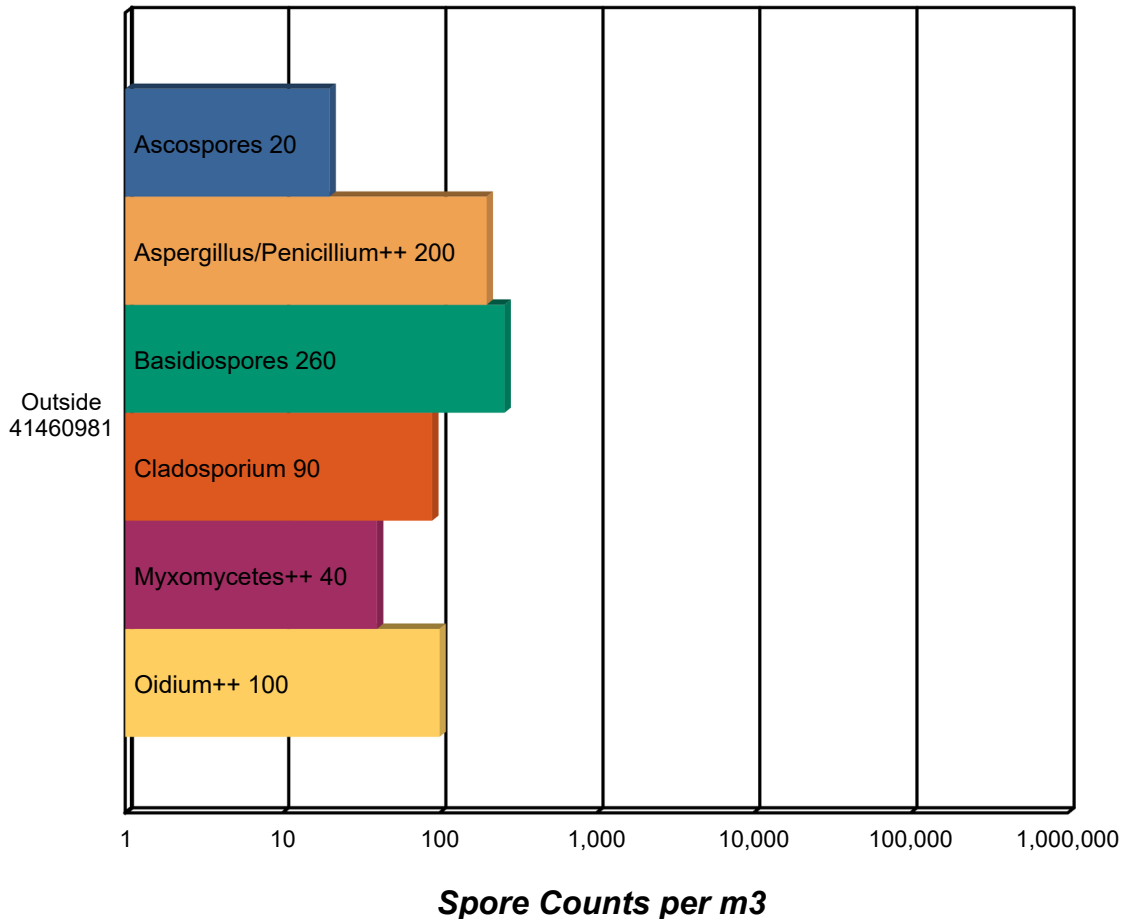
### Spore Trap Report: Total Counts

| Ascospores | Aspergillus/Penicillium++ | Basidiospores |
| Cladosporium | Myxomycetes++ | Oidium++ |

\* The chart is displayed using a logarithmic scale. Bar size is not directly proportional to the number of spores.

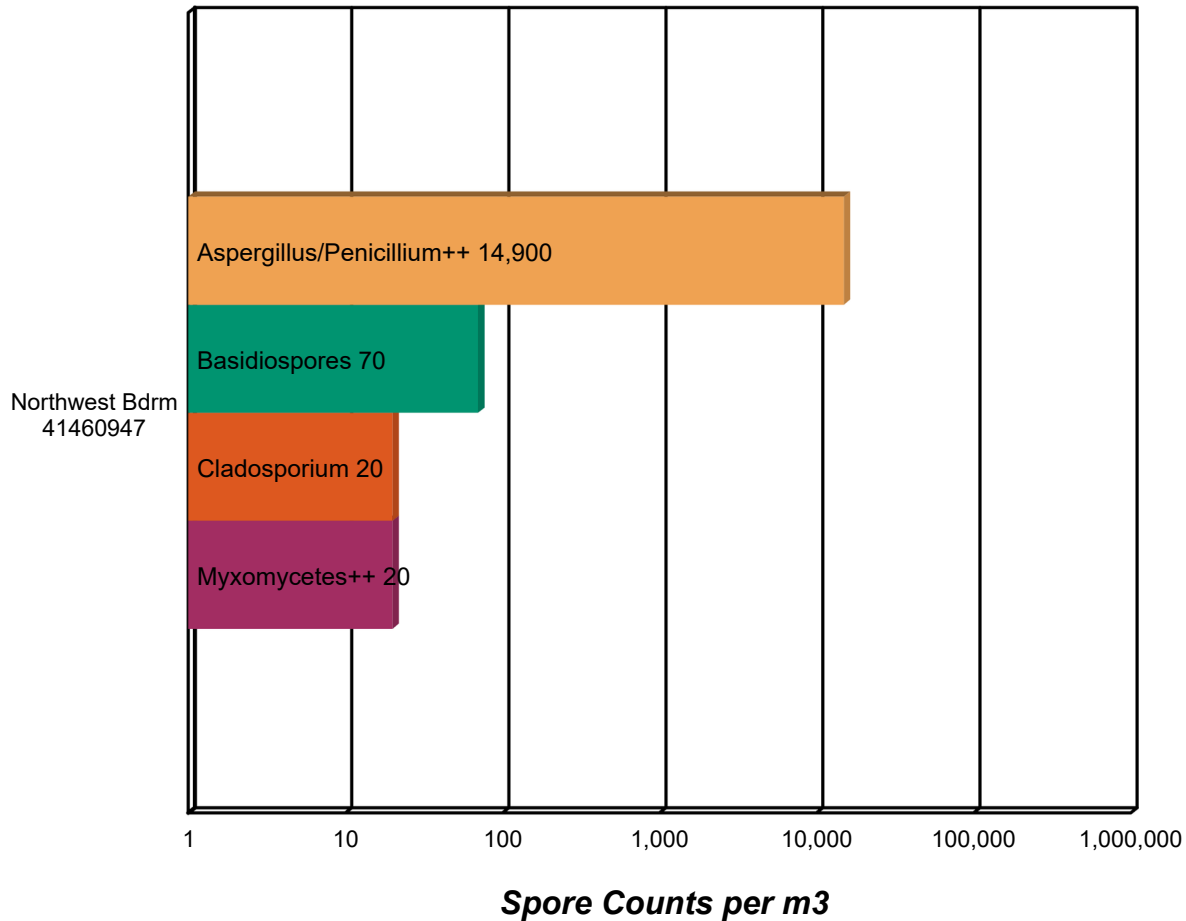
### Spore Trap Report: Total Counts

| Ascomspores | Aspergillus/Penicillium++ | Basidiospores |
| Cladosporium | Myxomycetes++ | Oidium++ |

\* The chart is displayed using a logarithmic scale. Bar size is not directly proportional to the number of spores.

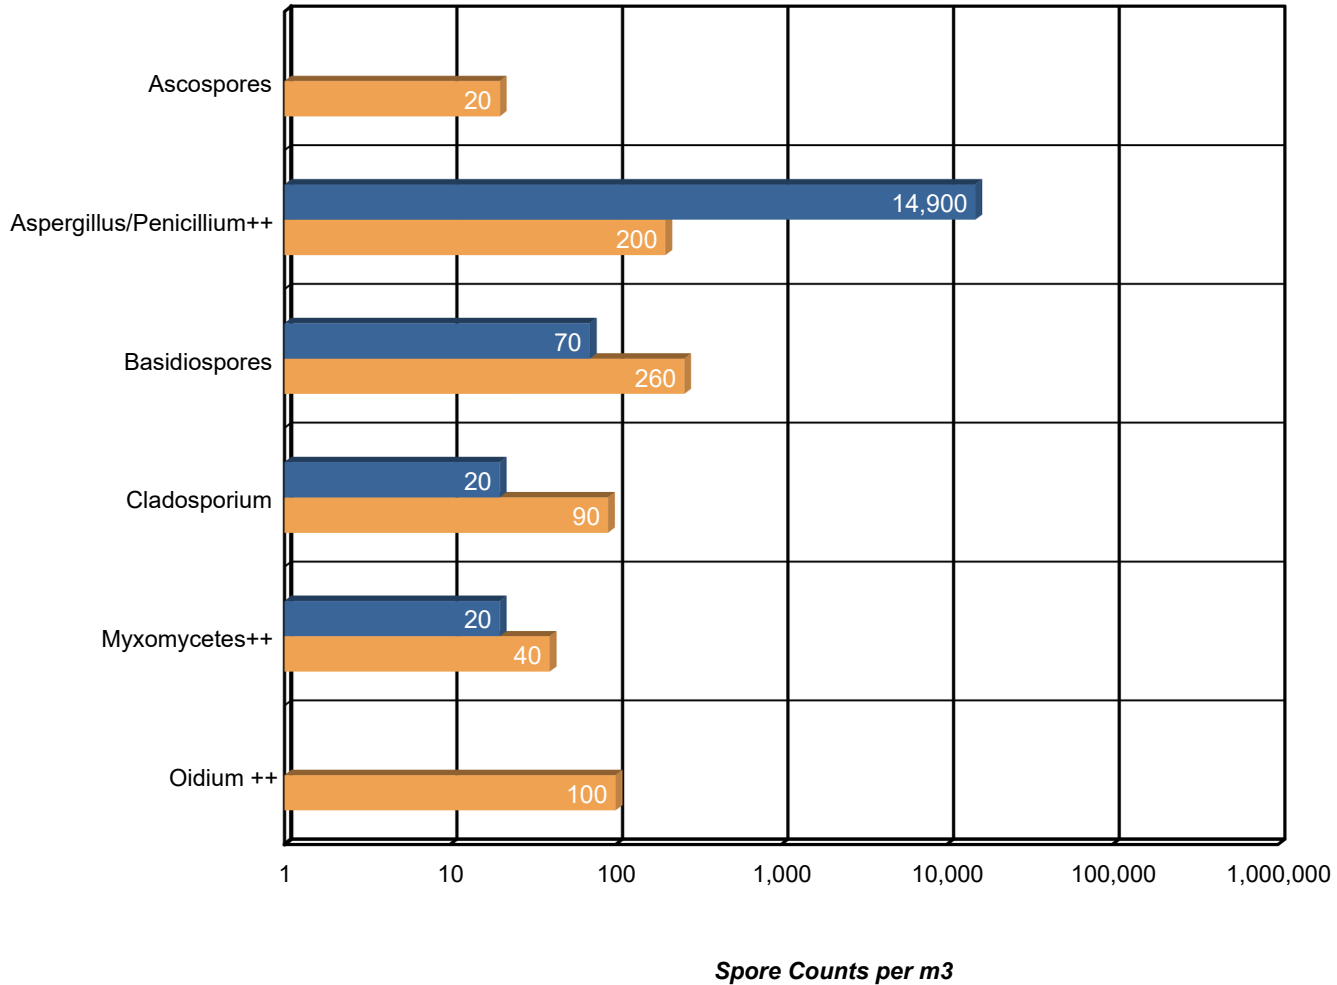
### Background Comparison Chart

■ 41460947 Northwest Bdrm ■ 41460981 Outside

\* The chart is displayed using a logarithmic scale. The bar size is not directly proportional to the number of spores.

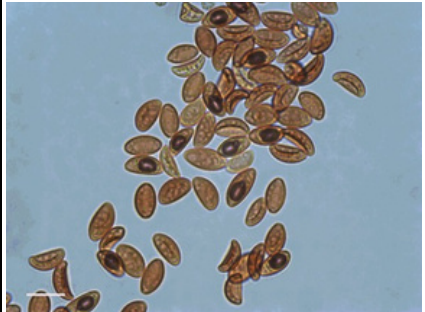
### ASCOSPORES

| <b>Other Comments</b> | Ascospores are the result of sexual reproduction and produced in a saclike structure called an ascus. All ascospores belong to members of the Phylum Ascomycota, which encompasses a plethora of genera worldwide. | |

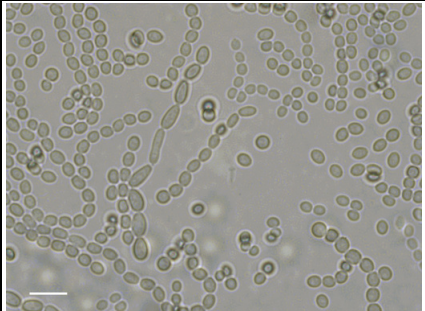
### ASPERGILLUS/PENICILLIUM++

| <b>Suitable Substrates in the Indoor Environment</b> | Grows on a wide range of substrates indoors ·Prevalent in water damaged buildings ·Foods (blue mold on cereals, fruits, vegetables, dried foods) ·House dust ·Fabrics ·Leather ·Wallpaper ·Wallpaper glue | |

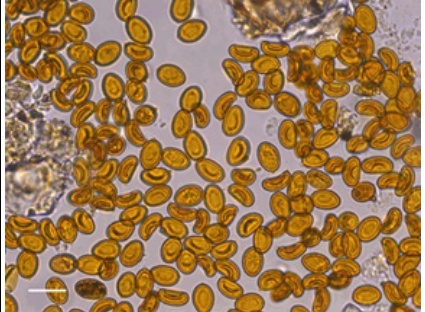
### BASIDIOSPORES

| <b>Other Comments</b> | Basidiospores are the result of sexual reproduction and formed on a structure called the basidium. Basidiospores belong to the members of the Phylum Basidiomycota, which includes mushrooms, shelf fungi, rusts, and smuts. | |

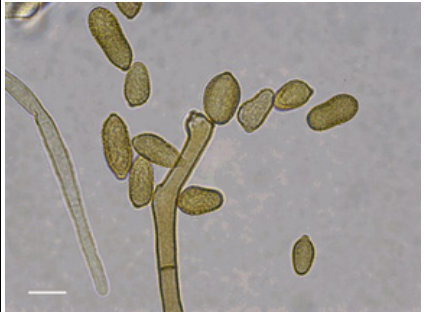
### CLADOSPORIUM

| <b>Suitable Substrates in the Indoor Environment</b> | Fiberglass duct liner. Paint. Textiles. Found in high concentration in water-damaged building materials. | |

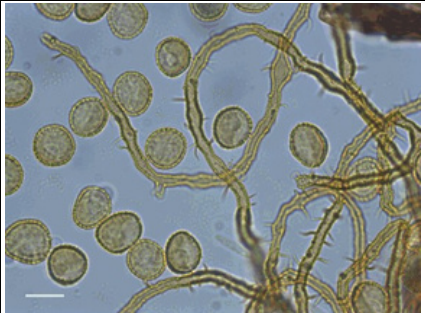
### MYXOMYCETES++

| <b>Other Comments</b> | Includes Myxomycetes, Smut, Rust, and Periconia. | |
